HARRY S. TRUMAN NATIONAL HISTORIC LANDMARK DISTRICT: A
NEIGHBORHOOD CASE STUDY

A REPORT

MASTER OF REGIONAL AND COMMUNITY PLANNING

KANSAS STATE UNIVERSITY
Manhattan, Kansas

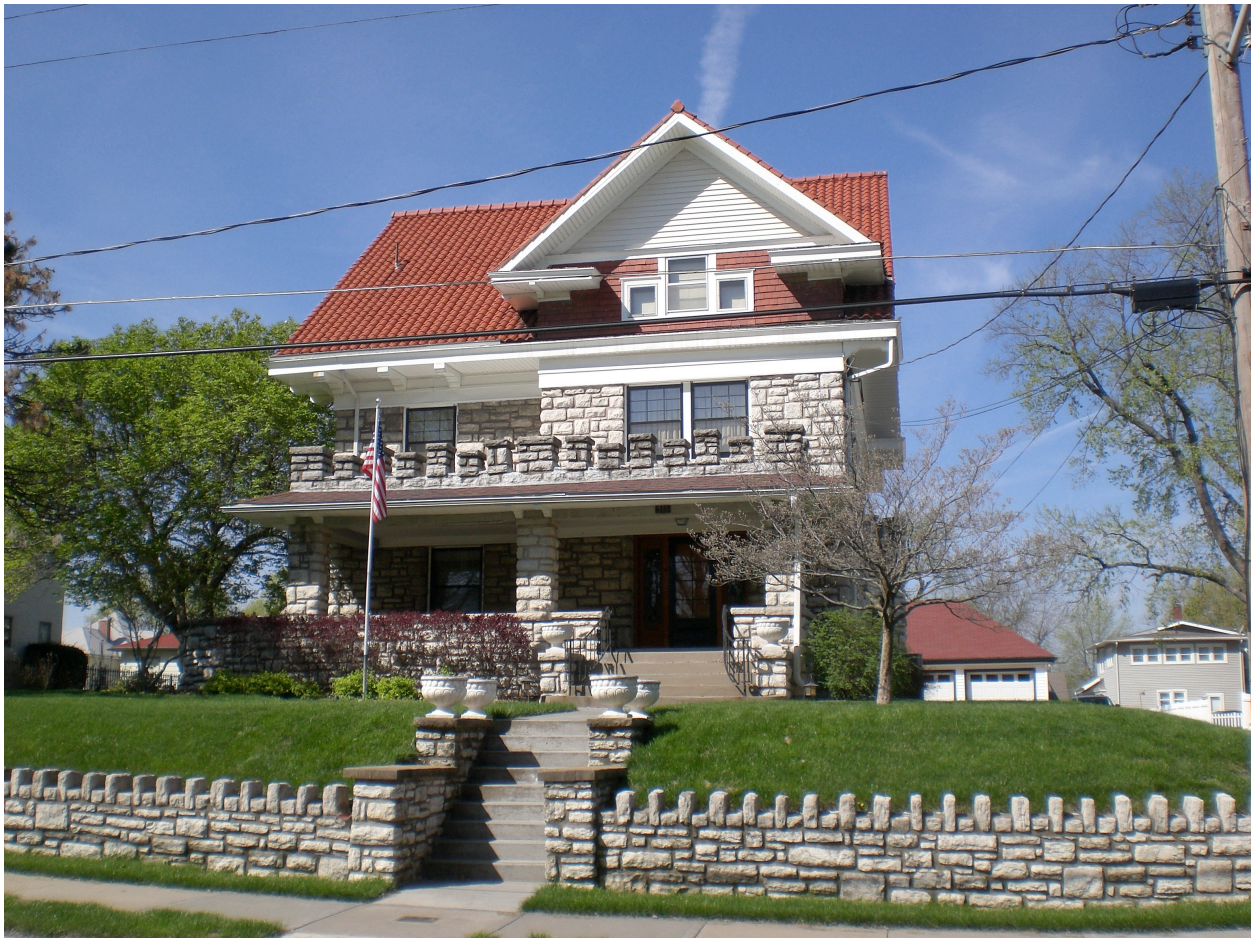
Figure 6.1 Example of a Structure in the Delaware Street Study Area

The landmark study area around Delaware Street consists of roughly twelve blocks in the City of Independence, Missouri. The structures are mainly residential with three churches and a few municipal buildings. There are also a few structures now owned by the United States government as part of the National Parks Service land, however these structures are all residential in nature and were originally occupied houses. The structures in the study area are primarily wood frame construction with a few brick structures in the neighborhood. There are two structures in the study area whose primary building material is native limestone (Figure 6.1). Most structures in the study area are either one to two stories in height, although a few are two and half stories. Many of the structures date to around the turn of the twentieth century. The houses have ample front yard space and many also have large back yards as well.

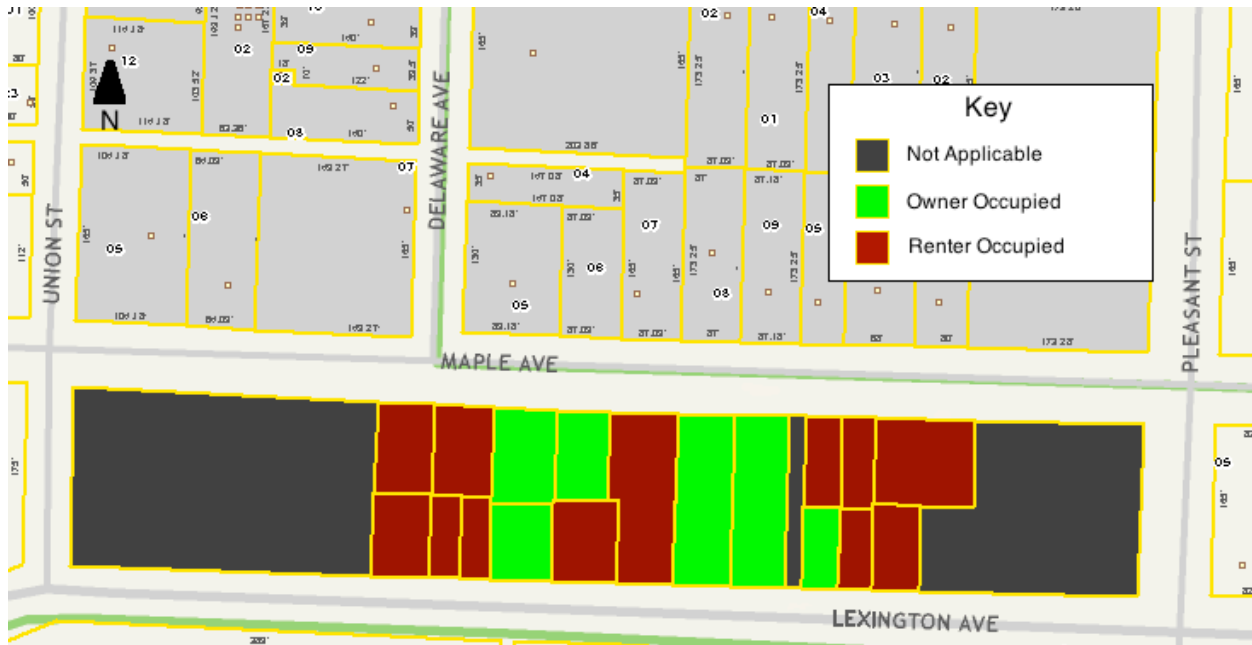
**Figure 6.2 Rental Cluster Between Maple Avenue and Lexington Avenue
(adapted from Jackson County GIS)**

The three categories for occupancy are owner occupied, renter occupied, or vacant. These were determined from county address records and field observations. Of the 141 total parcels, 22 were ineligible for occupancy evaluation. This was mainly due to either having no structure on the parcel or being owned by a municipal body such as the city. Two properties were identified as vacant, giving the study area a vacancy rate of 1.68%. Thirty-three properties are renter occupied. The study area has a 27.7% renter occupancy and a 70.59% owner occupancy rate, with 84 structures being owner occupied. The renter occupied housing is scattered throughout the study area with one cluster of twelve properties in the block between Maple Avenue and Lexington Avenue (Figure 6.2). Of the remaining parcels in that block, only six are owner occupied.

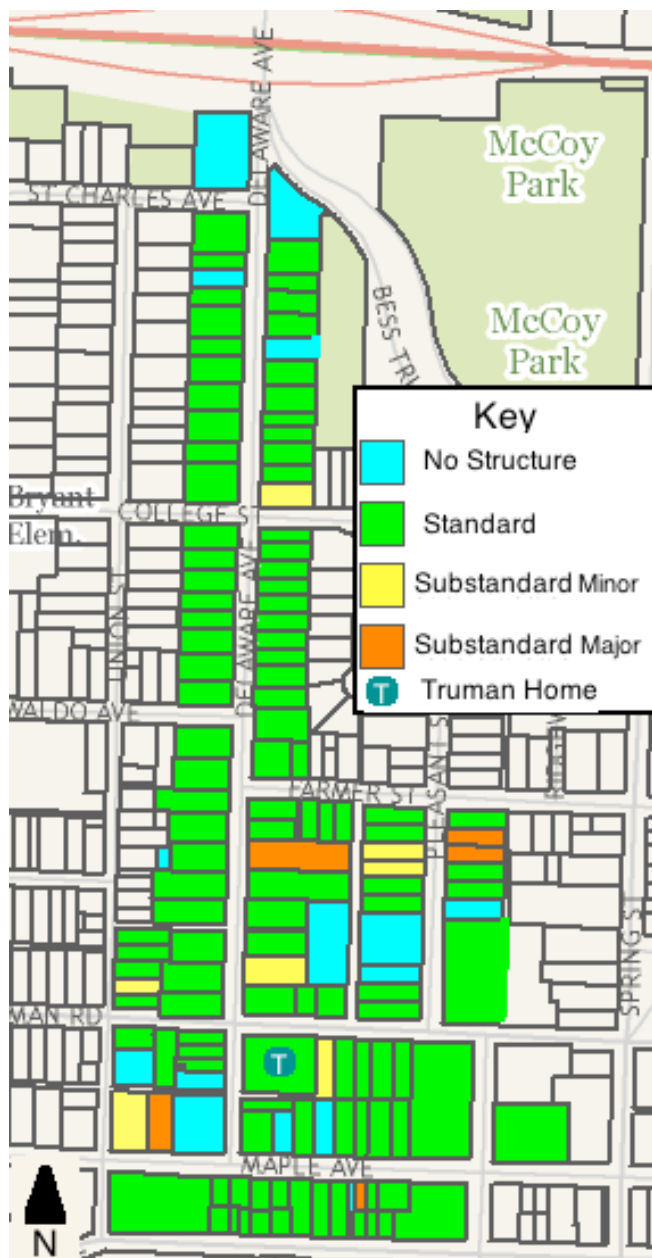
Figure 6.4 Structure Condition Map of Delaware Street Study Area (adapted from Jackson County GIS)

The overall condition of the study area was standard. Although the study area consists of 141 parcels, 13 parcels are either yards of the adjoining properties, parking lots, or another form of a vacant lot. The excluded parcels are shown in light blue in Figure 6.4. This left 128 parcels with structures to be analyzed for this variable. Of the 128 parcels identified as having structures, seven were substandard minor. The National Park Service owns one of the substandard minor properties. This property had obvious signs of ongoing work to the structure in order to improve its current condition. Five properties were substandard major. There were

not any properties that were ranked as dilapidated. Two of the substandard major properties were vacant, two are renter occupied, and one is owner occupied. It should be noted that if immediate attention is not paid to the substandard major structures, they will quickly deteriorate to a dilapidated state. It will not take much time for these structures to reach uninhabitable conditions. Only one substandard major structure had visible signs of rehabilitation work occurring.

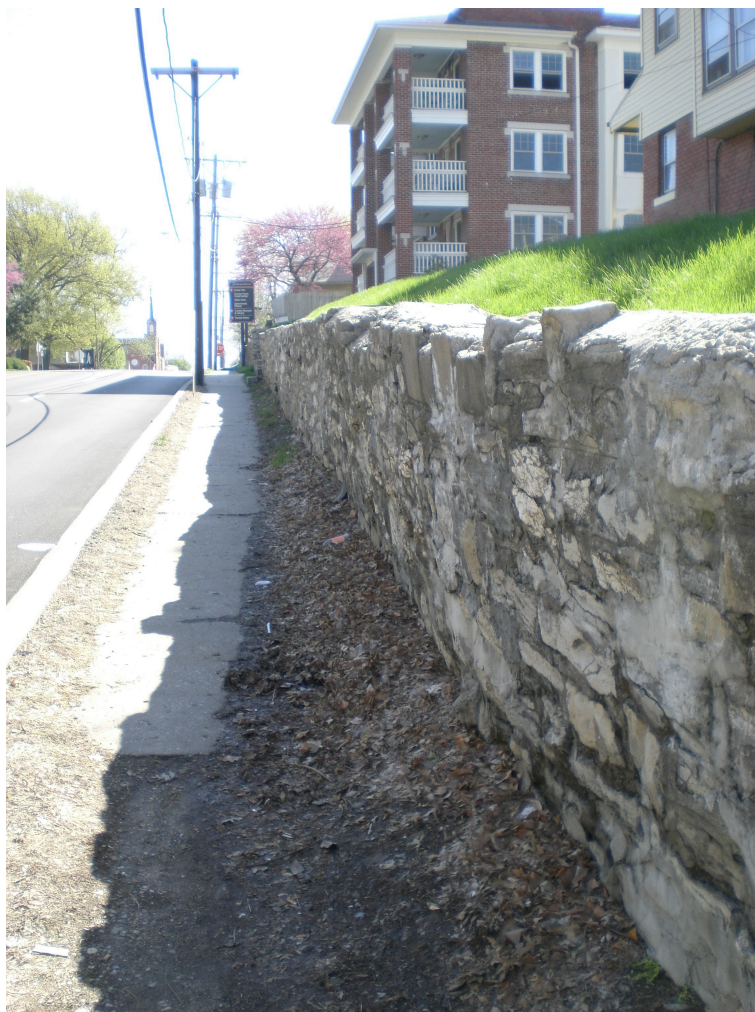
Figure 6.6 Example of a Substandard Sidewalk within the Delaware Street Study Area

few areas where the sidewalk sections need to be replaced due to large cracks or uneven surfaces. This is primarily evident on the northeast and southeast corners of the Truman Road and Union Street intersection (Figure 6.6). This intersection received the one substandard major rating in the study area. There were also 17 substandard minor ratings given for the issues discussed above.

There are a few portions of some blocks where the sidewalks need minor repairs and cleaning work such as removal of weeds. Attention should be paid to the zoning of the area. Some properties are improperly zoned or inconsistently zoned. For instance, one church is zoned commercial while another is zoned high density residential. Perhaps even a special zoning designation for these sites might be useful. Downzoning of the high density, R-30, properties might also be considered to be better for the historic context of the area.

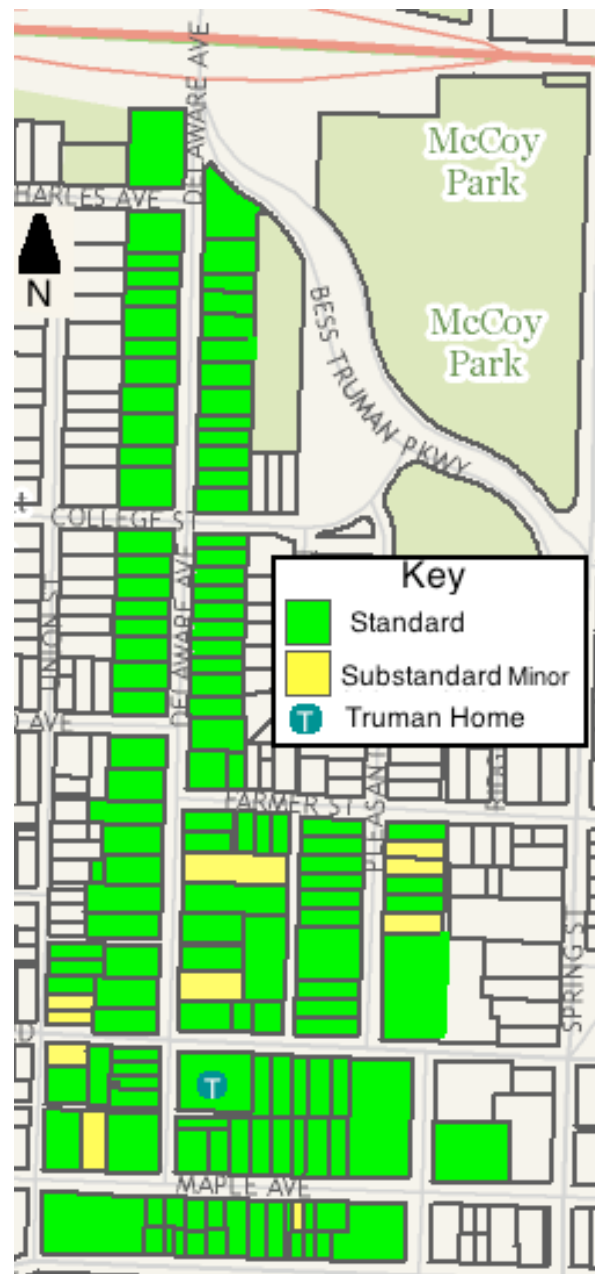
Figure 6.7 Overall Condition of the Delaware Street Study Area Parcels

Overall, the study area has a housing stock that is in good condition. The environs and sidewalks in the area are also in a well-maintained state. Of the 141 parcels, only 10 had an overall condition rating worse than standard and those parcels were still rated as substandard minor (Figure 6.7).

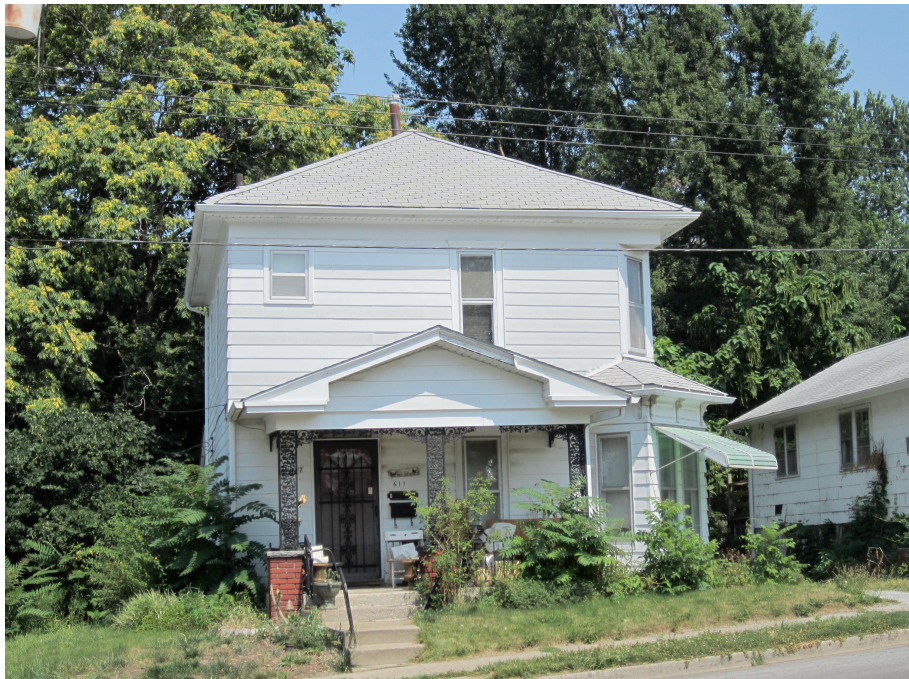
Figure 6.8 Example of a Structure in the Osage Street Study Area

The study area around Osage Street consists of roughly eight blocks in the City of Independence, Missouri. The structures are mainly residential with a few church buildings and a bank. The structures are primarily wood frame construction with a few brick structures in the neighborhood. Some structures in the study area have limestone porches and one structure's primary building material is native limestone. Most structures in the study area are either one to two stories in height. Many of the structures date to around the turn of the twentieth century. Some structures have limited yard space but most have sufficient front and back yards.

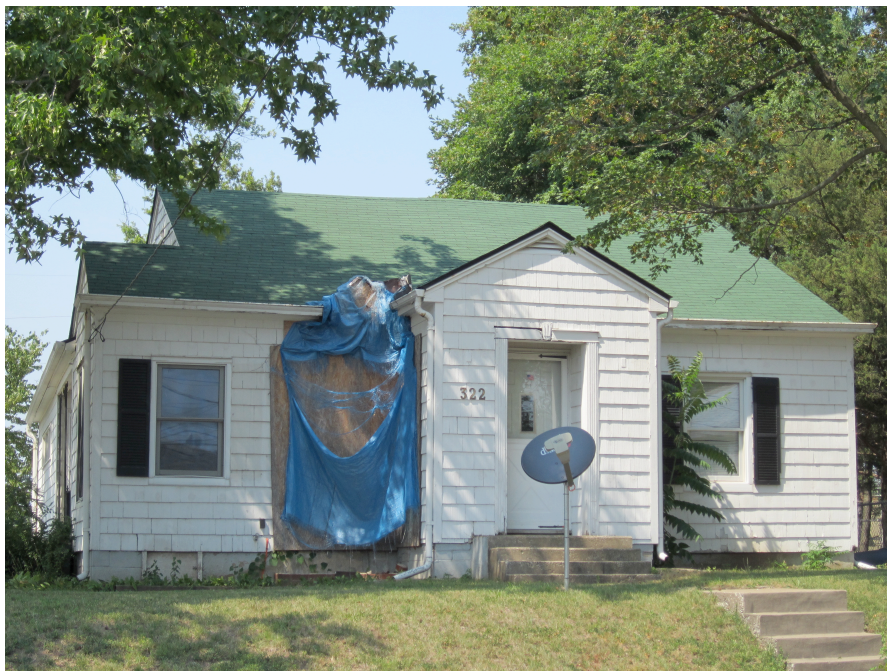
Figure 6.11 A Dilapidated Structure in the Osage Street Study Area

The overall condition of the study area was between standard and substandard. Most of the structures received one of those ratings. Around a quarter of the properties were substandard minor. Of the 136 structures identified, twelve were substandard major. One property was ranked as dilapidated and it appeared as though there was work being done to remedy its condition. Figure 6.11 shows the temporarily patched hole in the side of the dilapidated property as well as a young tree that appears to be growing from the side of the foundation of the structure. Although a little over 60% of the study area was considered standard, 10% was rated as at least substandard major. There was no spatial distribution pattern to the locations of the worst rated properties.

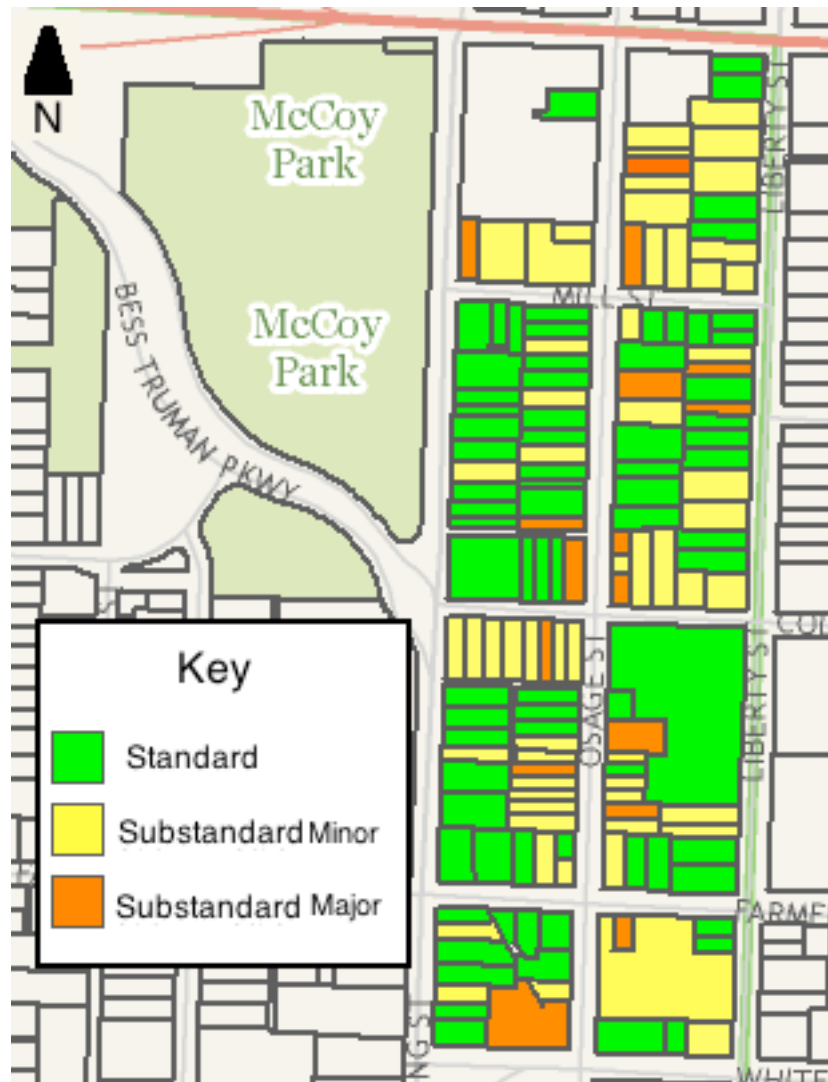
Figure 6.13 Map of Overall Condition in the Osage Street Study Area (adapted from Jackson County GIS)

Although the entire study area is not in poor condition, there are multiple blocks that are not in good condition. Half of the parcels were less than standard with their overall condition. Although none were dilapidated overall, 16 were substandard major which is 10.9% of the study area. The parcels on Spring Street were almost entirely standard. This is the only section of the study area that can be classified as good condition.

The area could be greatly improved if the city encouraged restoration of the sidewalks in the area. There are also some problems with the zoning in the study area. Some properties are improperly zoned or inconsistently zoned. The two southernmost blocks are zoned C-2 yet one of these blocks is clearly residential housing.

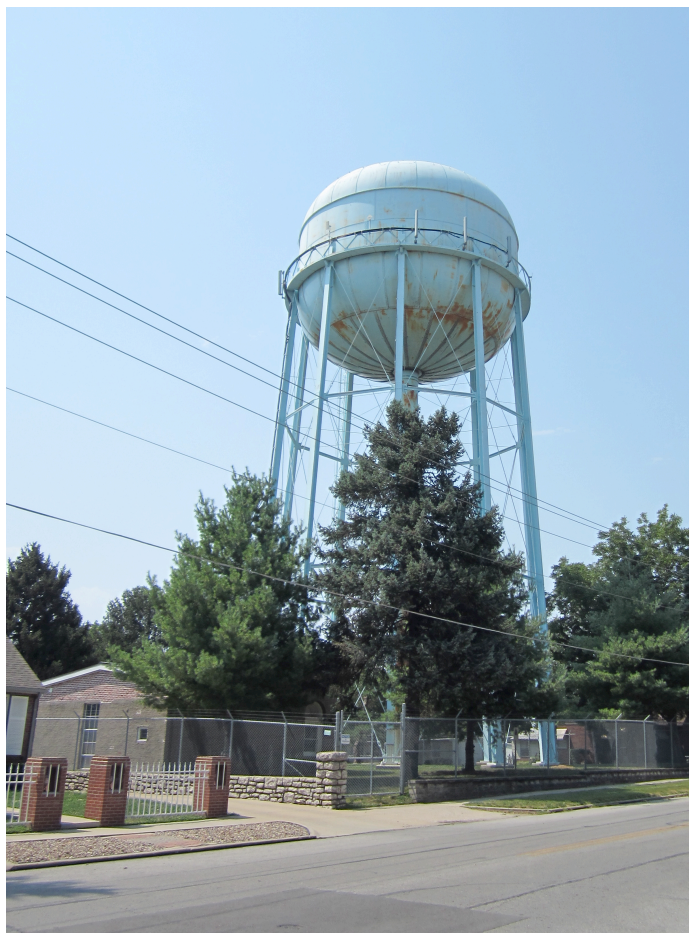
Figure 6.14 Municipal Water Tower in the Main Street Study Area

occupancy, style, year constructed, and structure condition were not looked at for these parcels. This left 127 parcels to be analyzed for the other factors. Six parcels were non-residential uses such as the churches and a city water tower (Figure 6.14). These parcels were still looked at in terms of structure condition and the other elements except occupancy.

The study area around Main Street consists of roughly eleven blocks in the City of Independence, Missouri. The structures are mainly residential with four churches, some commercial structures, and a municipal water tower (Figure 6.14). The structures are primarily wood frame construction with a few brick structures in the neighborhood. Native limestone is used on some portions of a few structures, such for porches, or in the environment as landscape features and retaining walls. Most structures in the study area are either one to two stories in height, although a few are two and half stories especially on Main Street. Many of the structures

There are four buildings of significance in the Main Street study area. They are the water tower, Second Baptist Church, Saint Mary's Catholic Church and School, and the Trinity Episcopal Church. The water tower parcel has two structures on the property. The most noticeable structure is the blue modern day water tower that services the local residents. There is also a historic water tower structure on the property on Main Street near U.S. 24 Highway. Part of the North Main Water Tower, constructed in 1884, remains on the property today. The original structure was a 55 foot high brick tower with a 30 foot high wooden standpipe. The wooden portion burned after being struck by lightning. However, the brick structure can still be seen on the site today next to the modern water tower. In 1995 the historic water tower was dedicated as a National American Water Works Association Historic Landmark, one of only 11

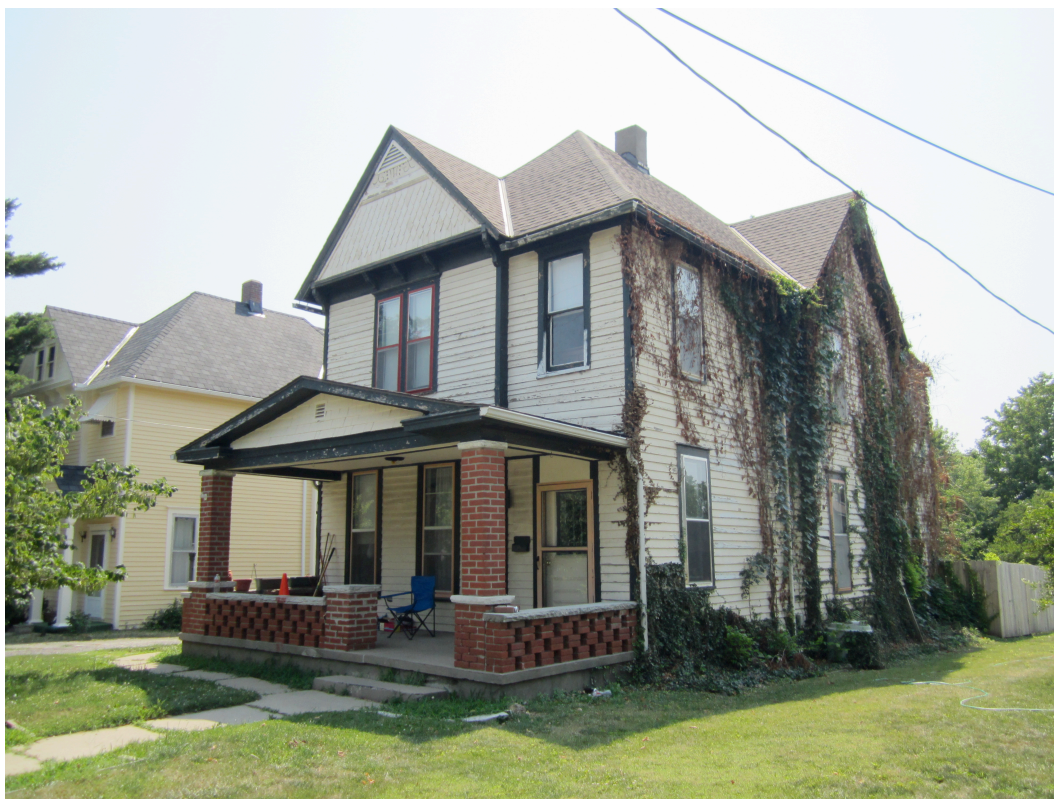
Figure 6.15 Example of a Structure in the Main Street Study Area

date to around the turn of the twentieth century. There are properties with large yards and there are also ones with very little space on the parcel other than the structure.

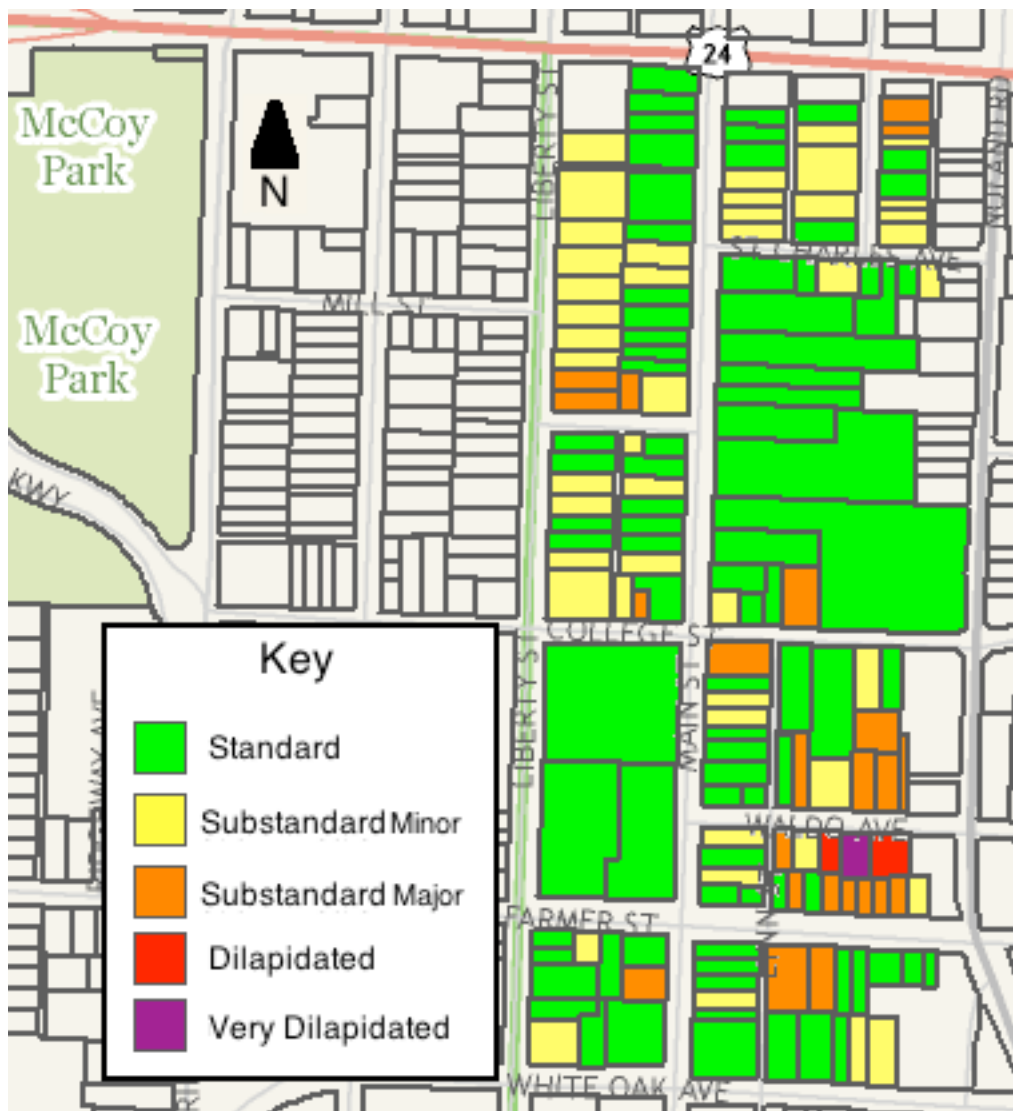
Figure 6.20 Map of Overall Condition in the Main Street Study Area (adapted from Jackson County GIS)

Most of the parcels on Main Street are not in bad condition and the study area as a whole is not horrible but there are areas of concern. A large portion of Liberty Street is substandard, mostly minor but with a few parcels classified as major. The area around Saint Charles Avenue and Lynn Street is not in standard condition. The area from the north side of Waldo Avenue to the south side of Farmer Street between Main Street and Noland Road is of the greatest concern. Many of these parcels have an overall condition of substandard major. Two parcels are dilapidated. One parcel on Waldo Avenue was actually in severe enough condition that it warranted the creation of the fifth category of “very dilapidated.” It is a vacant lot that features a

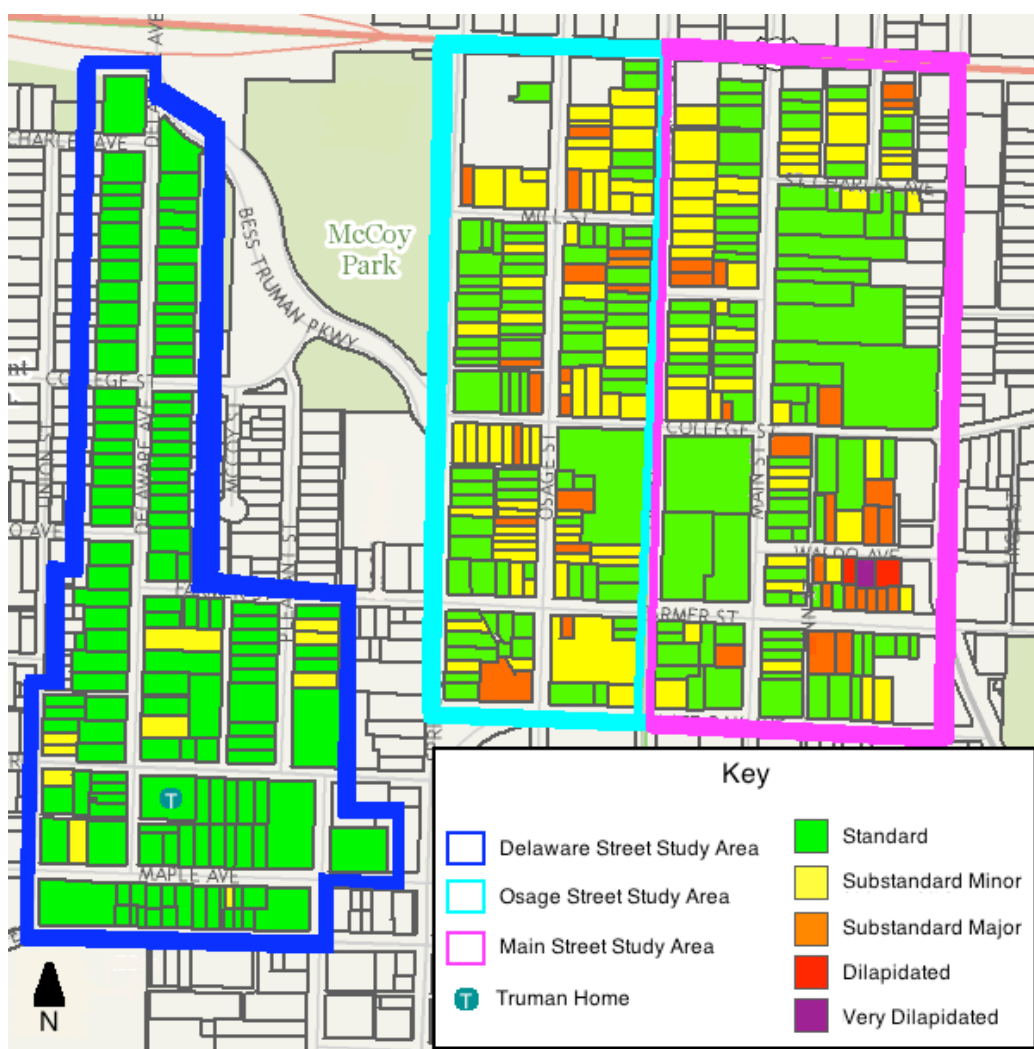
Figure 6.21 Map of Overall Condition in All Study Areas (adapted from Jackson County GIS)

fifth category; very dilapidated. Table 6.1 lists the overall condition findings and Figure 6.21 illustrates the findings geographically.

In conclusion, the condition of the properties in the historic district, the Delaware Street Study Area, appear to be in significantly better than the conditions in the other two study areas. The percentage of standard properties in the Delaware Street Study Area is 40% greater than the highest comparable study area. The occurrence of substandard properties in the historic district is drastically less than in the other areas. Throughout the two comparable study areas there are 41 substandard major or worse properties. There are none in the Delaware Street Study Area. The highest, or worse, rating in the historic district is substandard minor of which 7.1% of the parcels received this rating. The Osage Street and Main Street study areas have 38.8% and 30.9% substandard minor properties. The structure conditions within the study areas are mostly standard however outside of the historic study area there is a higher prevalence of severe structure condition. There are more substandard major properties outside of the historic district and the district does not have any dilapidated structures whereas the other study areas have multiple dilapidated structures. The environment condition is slightly better within the historic district however the conditions are not bad in any of the study areas. Sidewalk condition showed a very stark difference between the study areas. The sidewalks within the historic district are good. The sidewalks outside of the historic district need a great deal of attention to their deteriorating condition. Overall, the Delaware Street Study Area seems to be in better condition than both the Osage Street Study Area and the Main Street Study Area.
